A STUDY OF IN-PLACE RUTTING OF ASPHALT PAVEMENTS

**E.R. Brown
Stephen A. Cross**

National Center for Asphalt Technology

NCAT Report No. 89-2

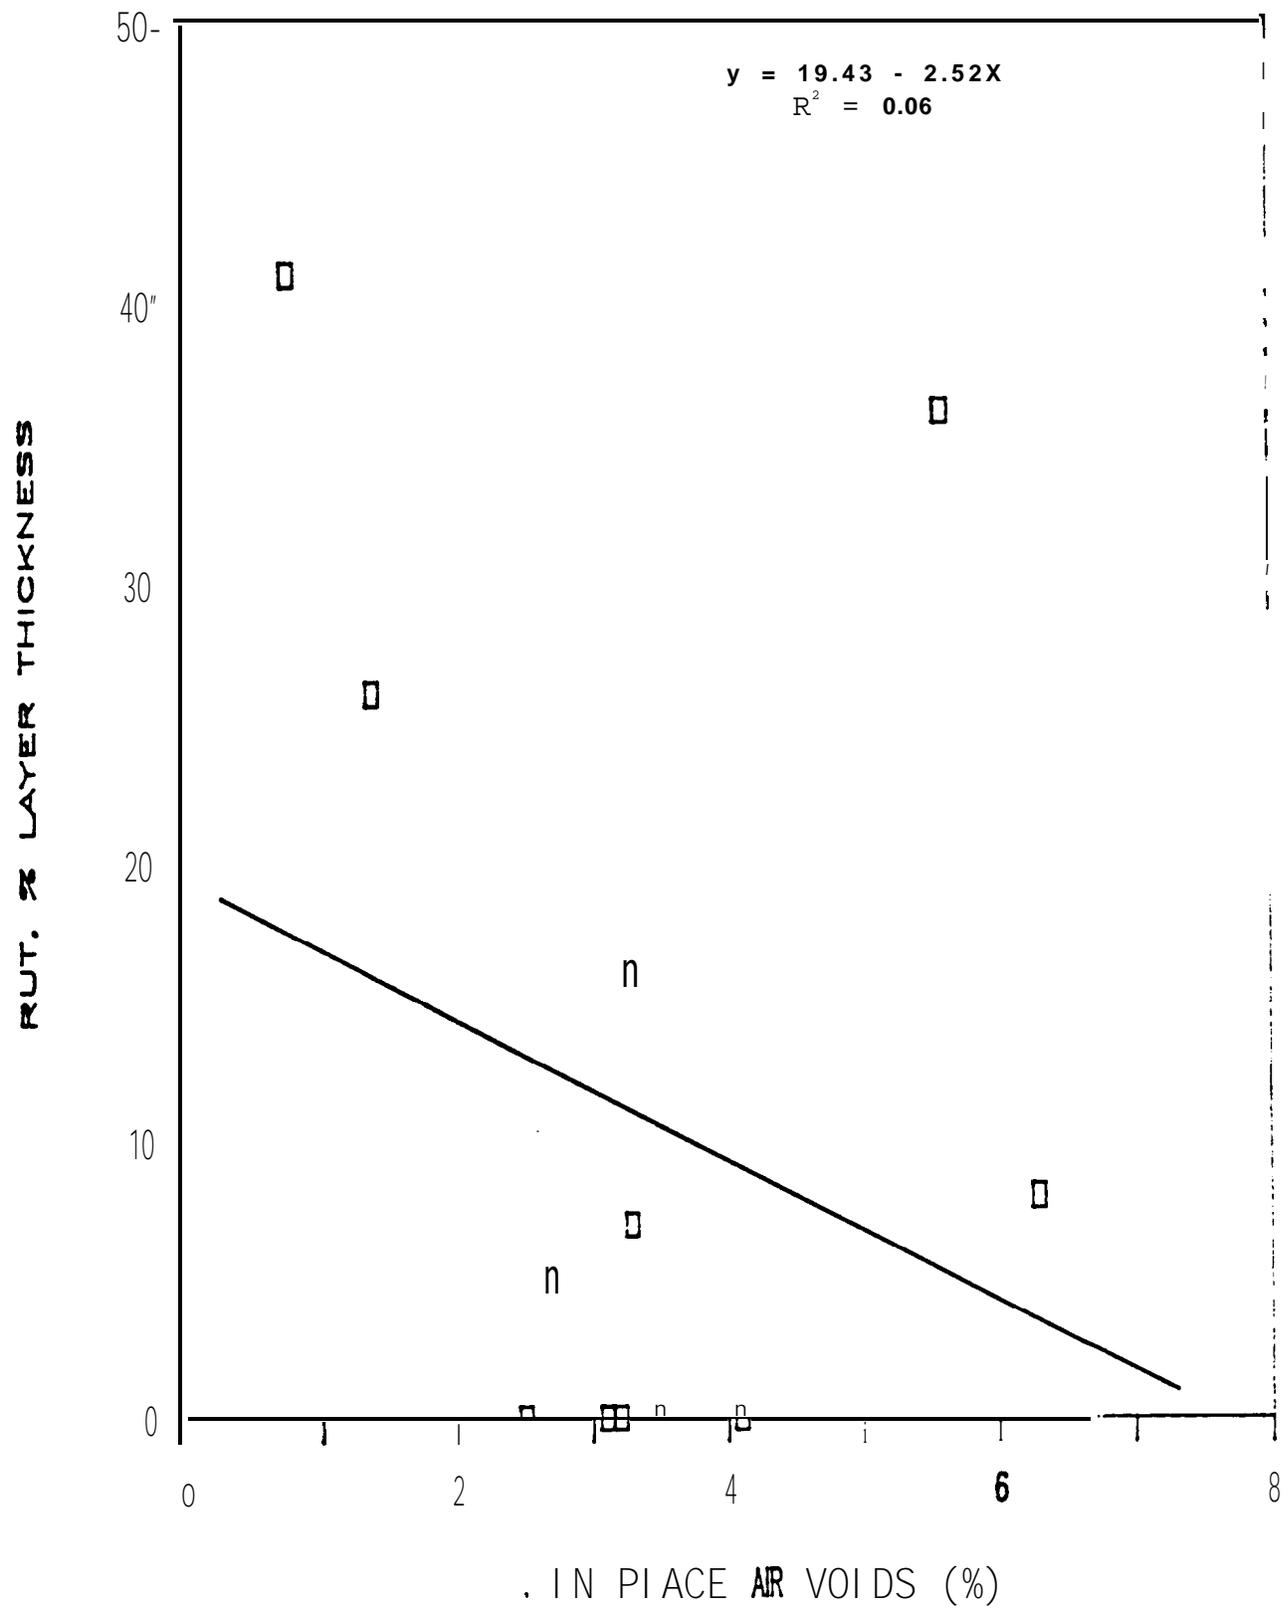
Figure 16. In-Place Air Voids vs. Layer Rutting

One of the primary causes of rutting is well-documented in the literature to be low air voids (3,4). A look at the relationship between rutting and minimum in-place air voids shows that the relationship between the two parameters has an $R^2 = 0.06$ (Figure 15). The data does show a trend of more rutting at lower air voids but the correlation coefficient is too low to be useful. It is possible the relationship between rutting and air voids is affected by an increase in air voids once the pavement begins to rut and shove. There is a good possibility that the void level decreases under compaction to some point at which rutting begins to occur and at which time the void level begins to increase due to shoving of the mixture.

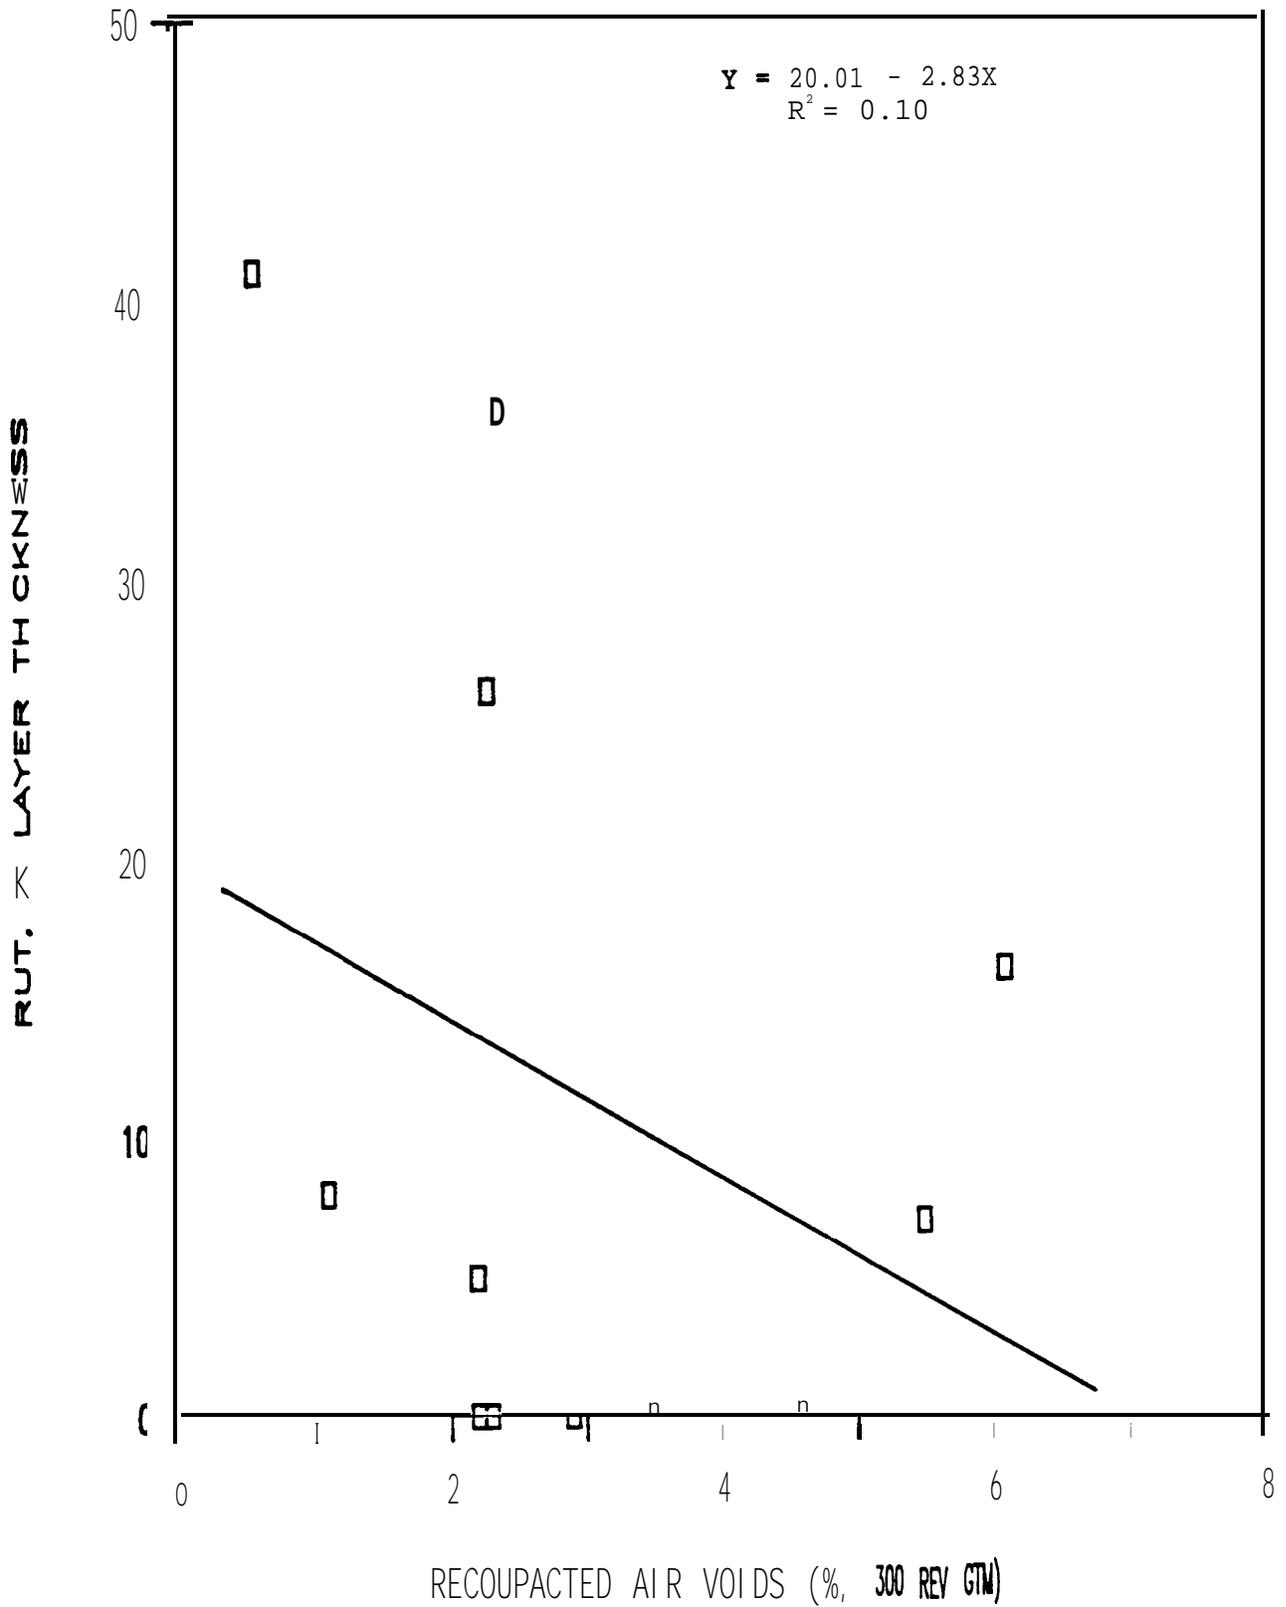
Figure 17. Recouped Air Voids vs. Layer Rutting

The relationship between layer rutting and recompacted air voids which has an $R^2 = 0.10$ is shown in Figure 17. This information clearly shows for the pavements tested that very little rutting occurs when the **recompacted** air voids are 3.0 percent or higher for **compactive** efforts of 75 blow Marshall and **Gyratory** with 120 psi, 1 degree and 300 revolutions. **The** voids data in Figure 17 was determined with the GTM. Three of the four mixes with more than 3 percent air voids have no rutting while the other mix has only 10 percent rutting. Significant rutting occurs in those layers having less than 3.0 percent recompacted air voids. In this case 3 of the 8 pavement layers have more than 20 percent rutting which is significant.

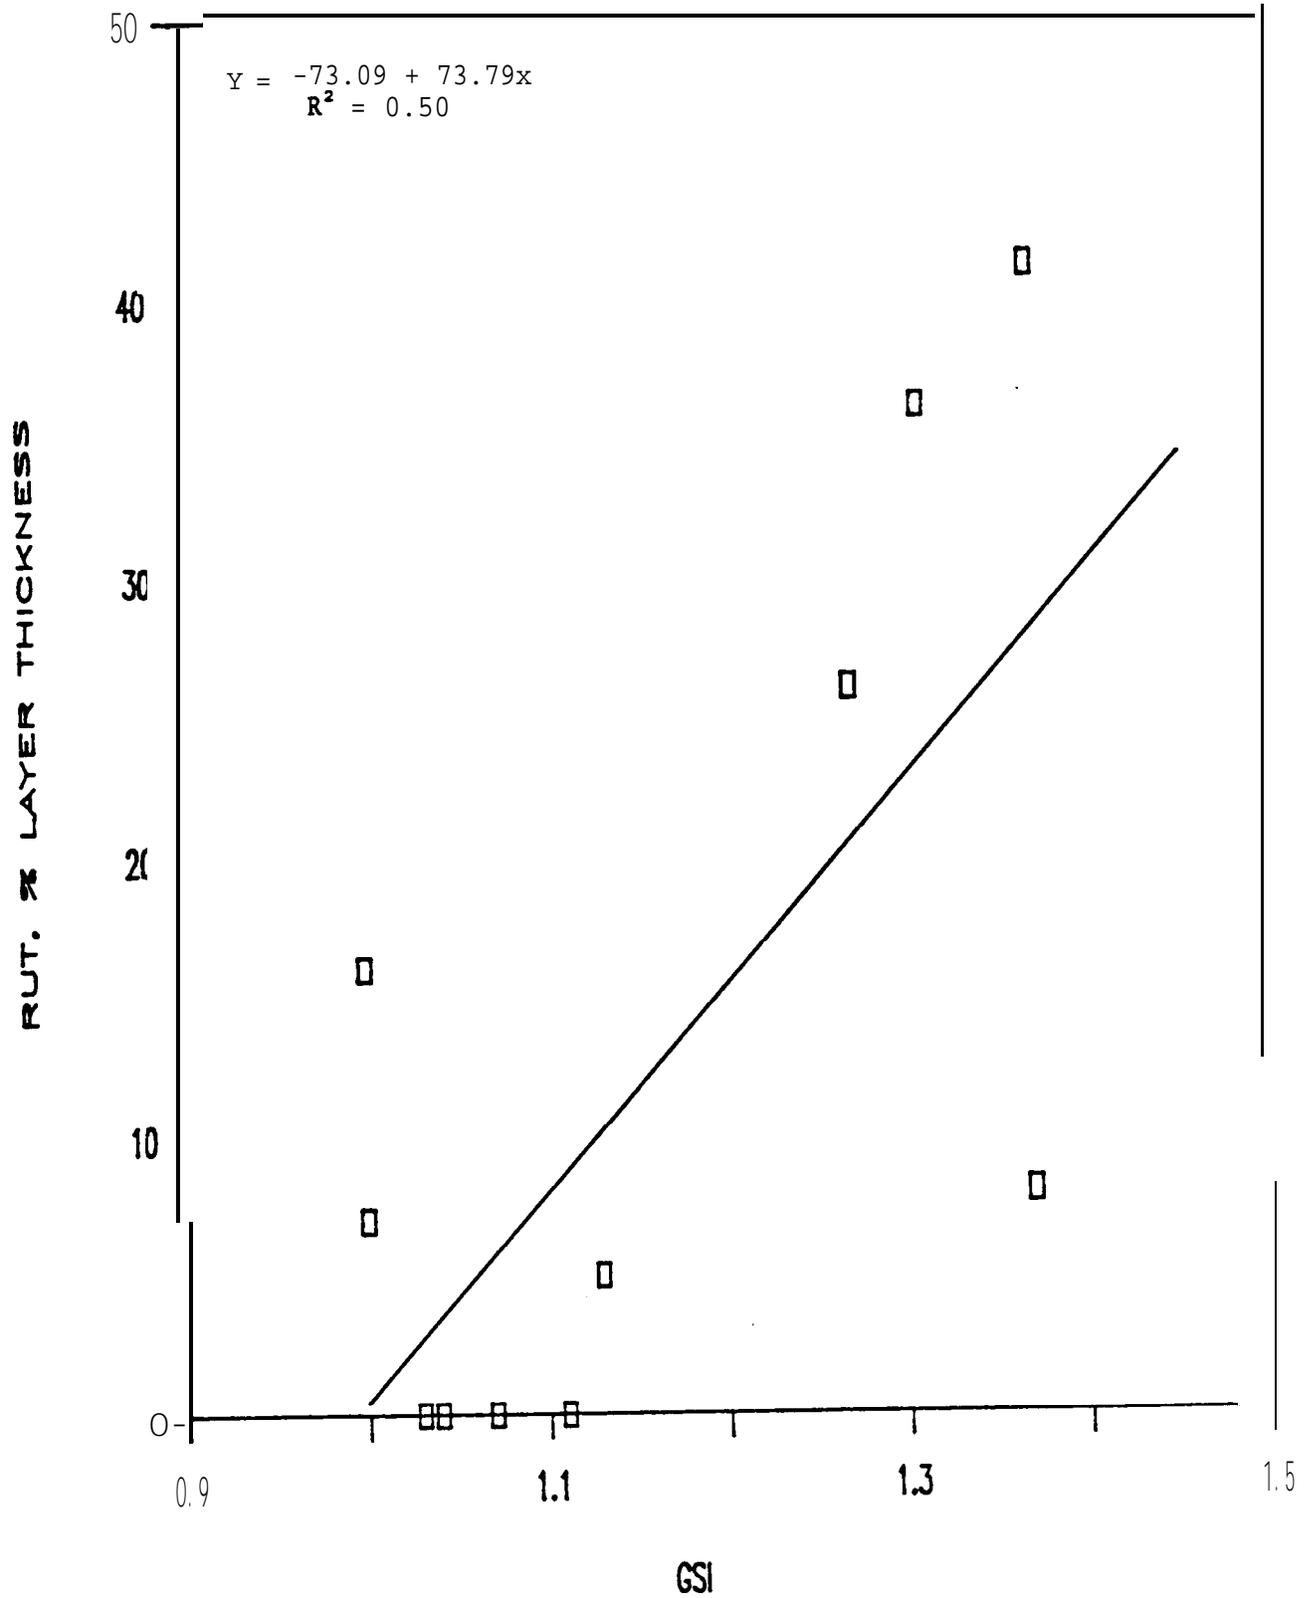
Figure 18. GSI VS. Layer Rutting

Another parameter that appears to relate **well** with layer rutting is the GSI which has an $R^2 = 0.50$ (Figure 18). When the GSI exceeds 1.1 the data shows that significant rutting can be expected. Only one of the five pavement layers that had GSI values less than 1.1 had experienced **significant** rutting.

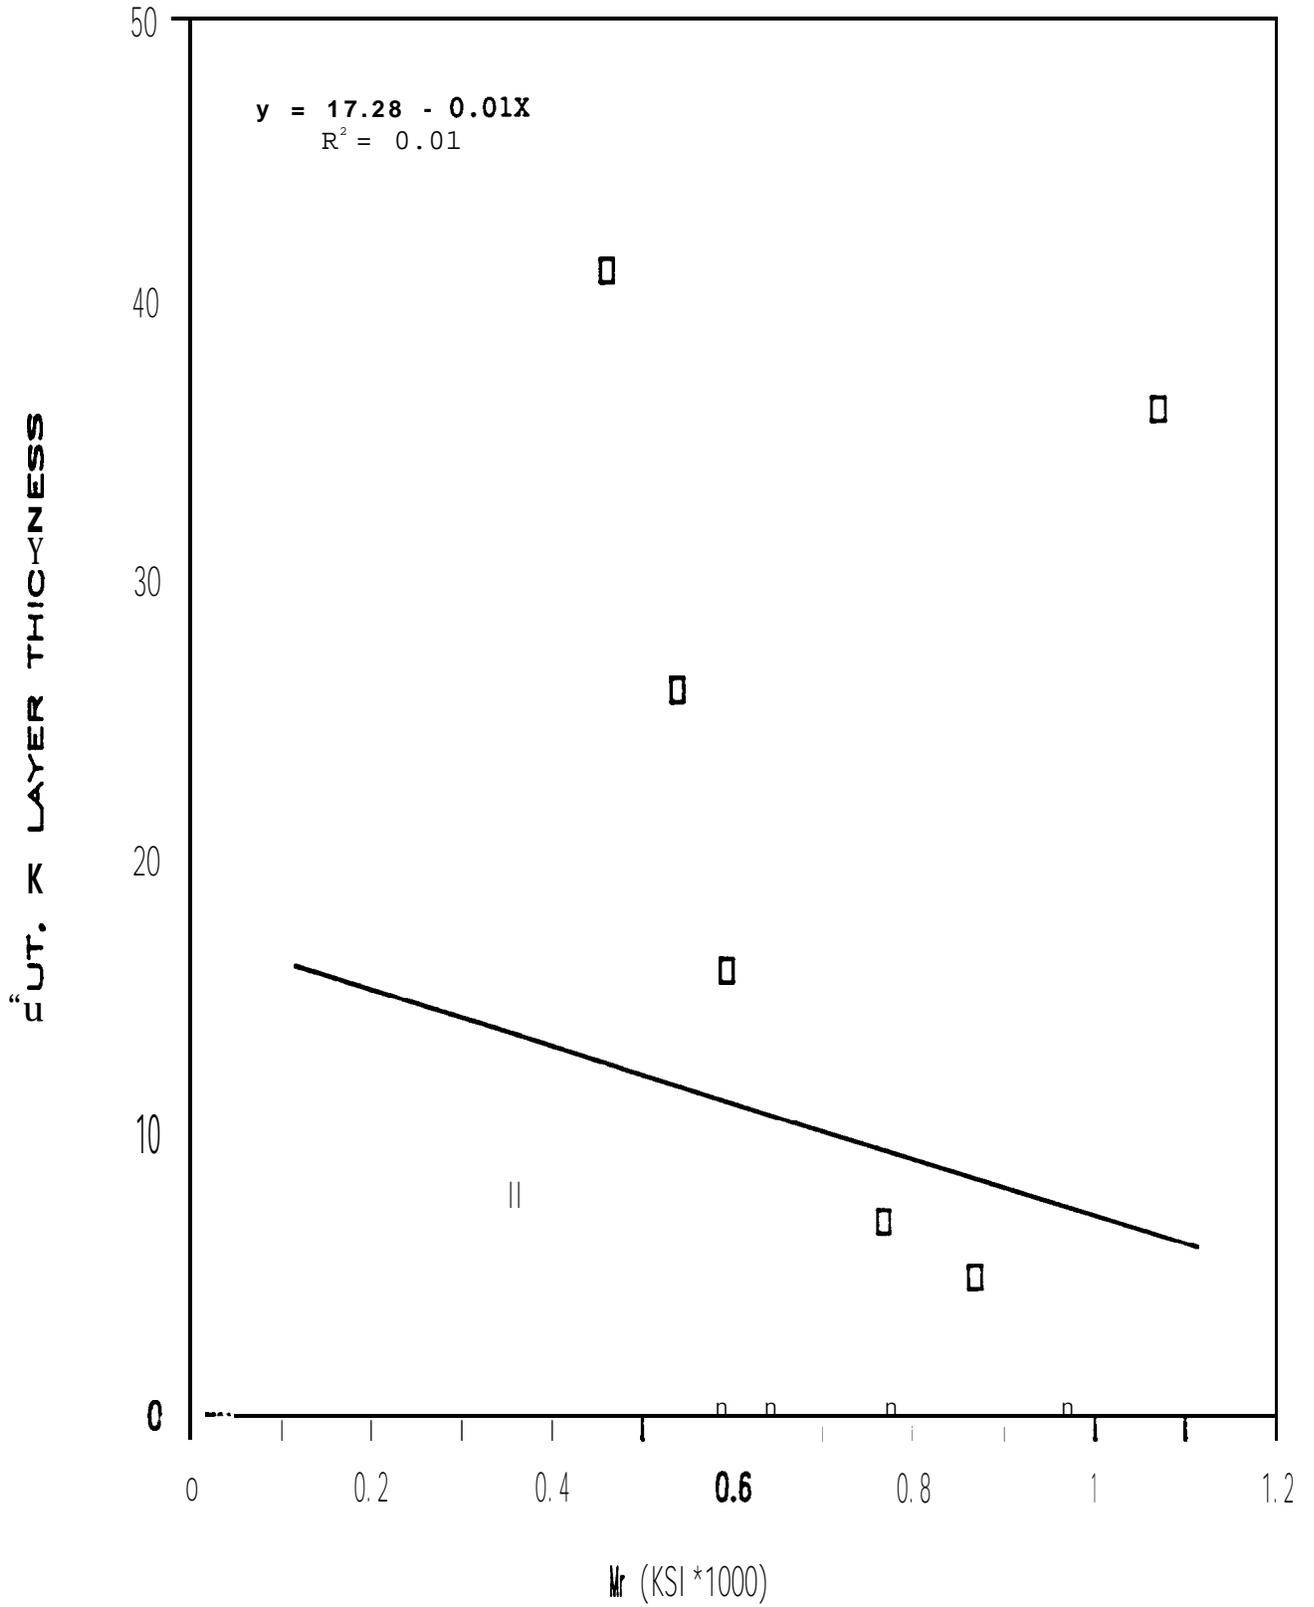
Figure 19. Resilient Modulus vs. Layer Rutting

Plots of resilient modulus and indirect tensile strength versus layer rutting are shown in Figure 19 and 20 ($R^2 = 0.01$ and 0.10 , respectively). It is obvious from these plots that there is no good relationship between layer rutting and these two parameters. There is no reason to expect a good relationship to exist between these parameters and rutting since rutting is due to compressive stresses and both of these tests measure tensile properties of the mixes.

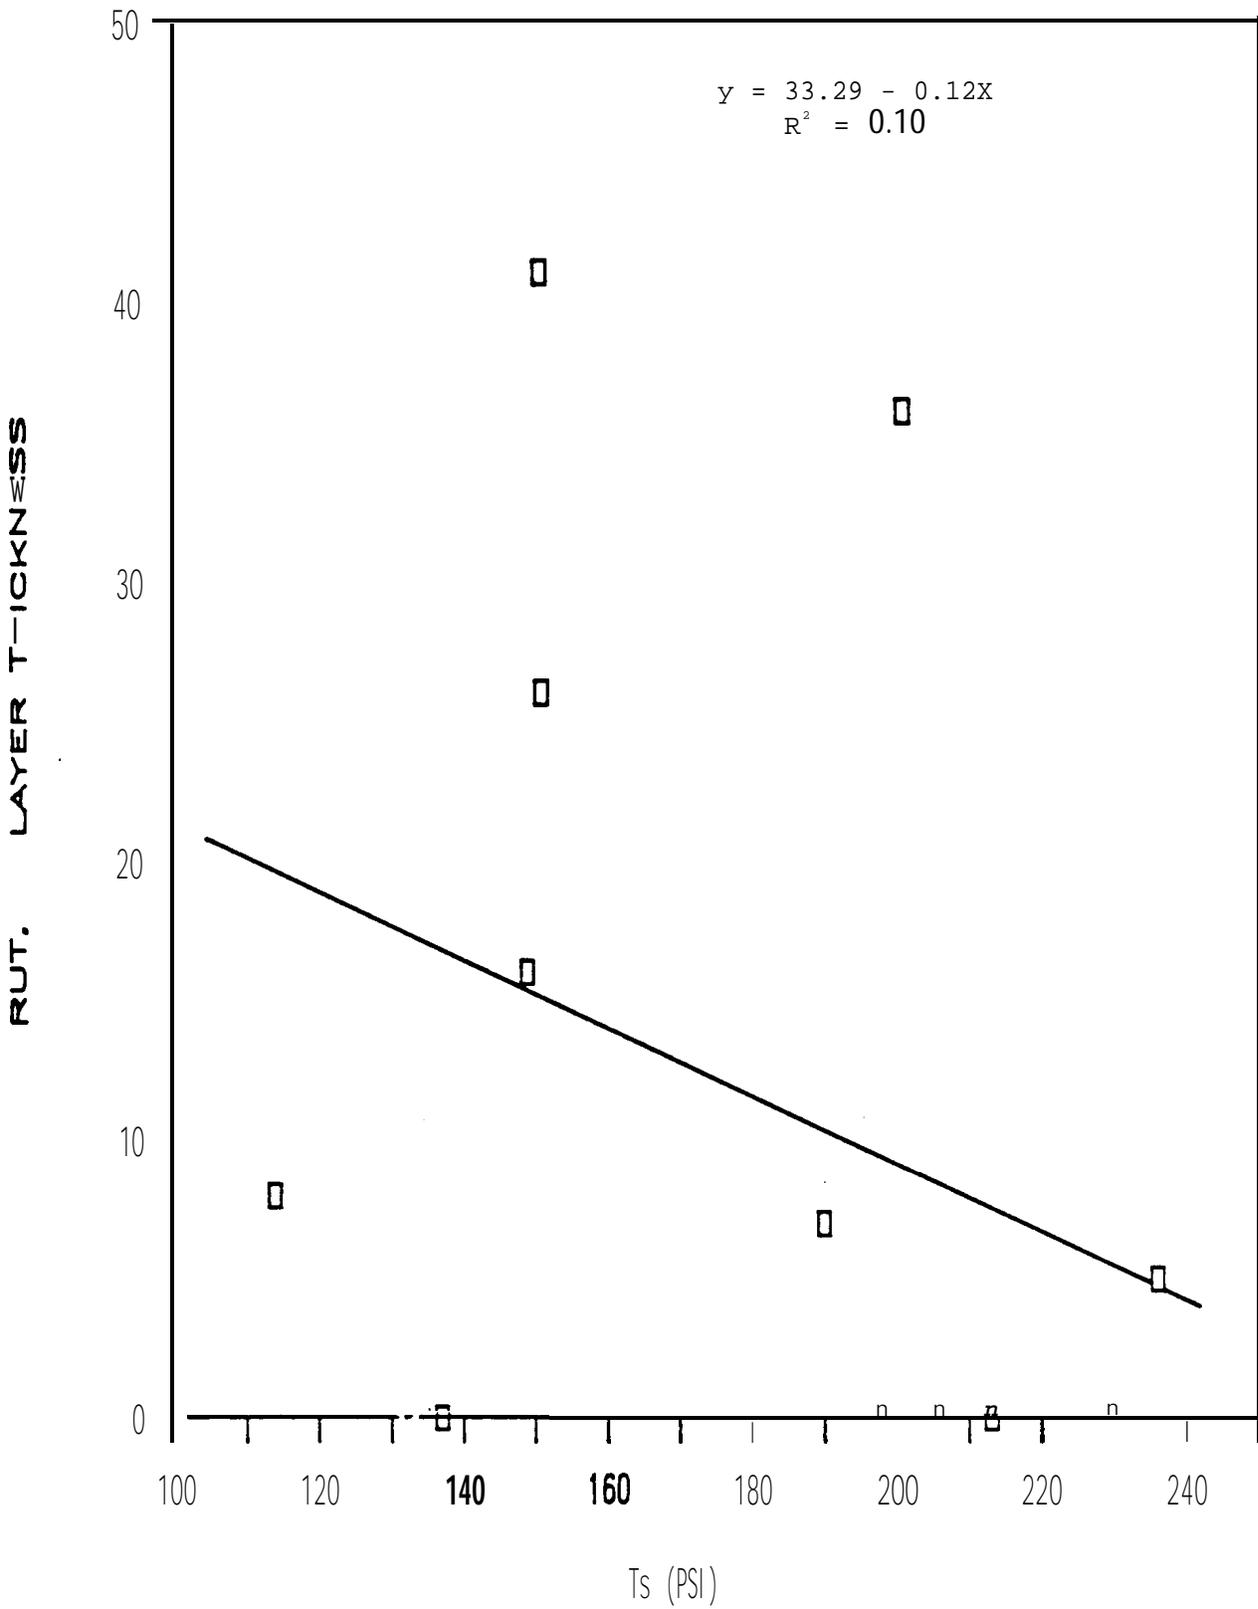
Figure 20. Indirect Tensile Strength vs. Layer Rutting

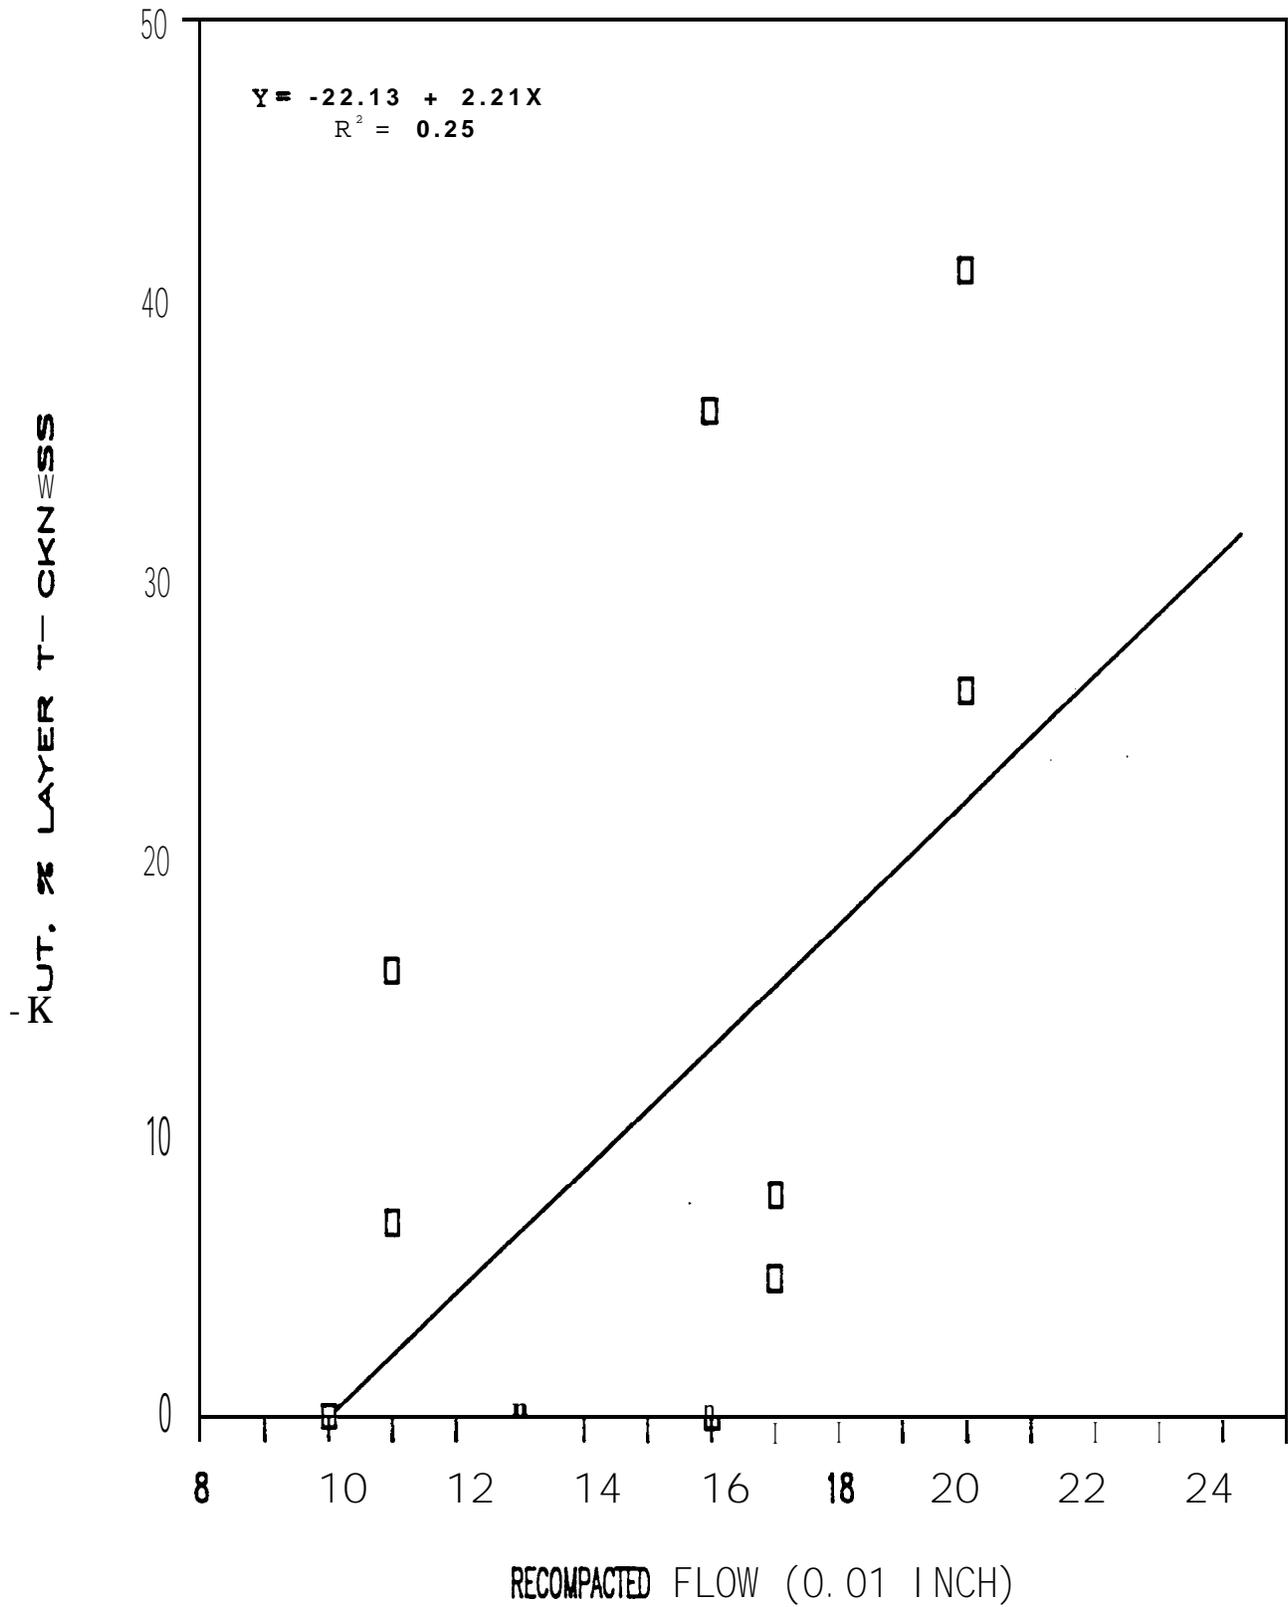
Figure 21. Marshall Flow vs. Layer Rutting

The Marshall flow in the recompacted samples appears to be an indicator of rutting potential with an $R^2=0.25$ (Figure 21). A flow above 16 for the pavements tested resulted in rutting equal to approximately 10-40 percent of layer thickness. A flow below 16 resulted **in** only 1 of the mixes having more rutting than 10 percent of layer thickness.
